# Technical Report 32-1265

# Surveyor Project Final Report

# Part I. Project Description and Performance Volume I

JET PROPULSION LABORATORY
CALIFORNIA INSTITUTE OF TECHNOLOGY
PASADENA, CALIFORNIA

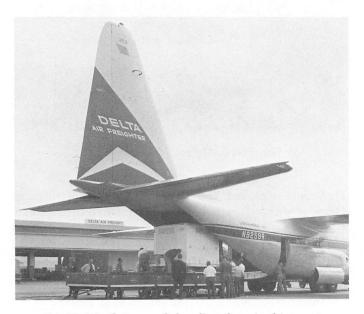
Fig. XI-19. Spacecraft loading for air shipment

The spacecraft was shipped to AFETR mounted on GTV 1 with test access tees installed and with the following items removed and packed separately:

- (1) Solar panel.
- (2) Planar array antenna.
- (3) Antenna/solar panel positioner.

- (4) Altitude marking radar.
- (5) Flight control sensor group.
- (6) Retro motor.
- (7) Battery.
- (8) Pyrotechnics.
- (9) Shock absorbers (dummy shock absorbers were installed).
- (10) Thrust chamber assemblies.
