Technical Report 32-1086

Surveyor II Mission Report

Mission Description and Performance

April 1, 1967

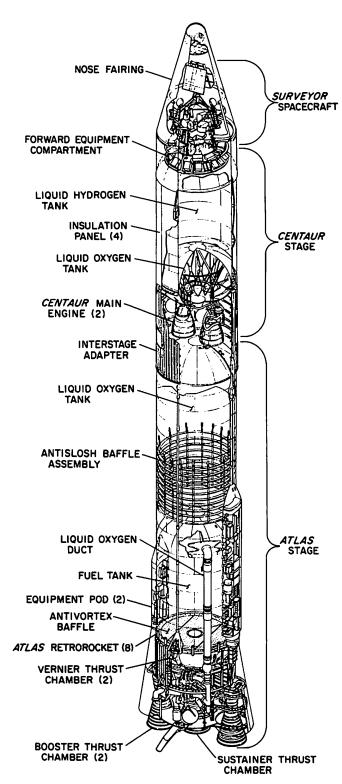
Fig. III-1. Atlas/Centaur/Surveyor space vehicle configuration

The first stage of the Atlas/Centaur vehicle is a modified version of the Atlas D used on many previous NASA and Air Force missions such as Ranger, Mariner, and OGO. The Atlas propulsion system burns RP-1 kerosene and liquid oxygen in each of its five engines to provide a total liftoff thrust of approximately 388,000 lb. The individual sea-level thrust ratings of the engines are: two booster engines at 165,000 lb each; one sustainer engine at 57,000 lb; and two vernier engines at 1000 lb each. The Atlas can be considered a 1½-stage vehicle because the "booster section," weighing 6000 lb and consisting of the two booster engines together with the booster turbo pumps and other equipment located in the aft section, is jettisoned after about 2.5 min of flight. The sustainer and vernier engines continue to burn until propellant depletion. A mercury manometer propellant utilization system is used to control mixture ratio for the purpose of minimizing propellant residuals at Atlas burnout.

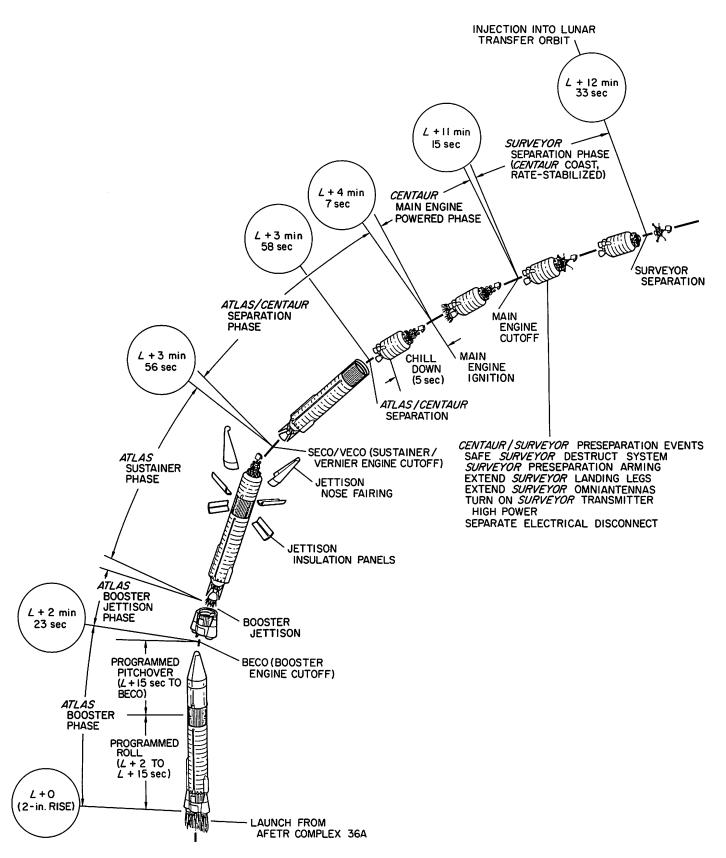
Fig. III-3. Launch phase nominal events

During the 66.3-sec period between MECO and spacecraft separation, the following signals were transmitted to the spacecraft from the *Centaur* programmer: extend spacecraft landing gear; unlock spacecraft omniantennas; turn on spacecraft transmitter high power. An arming

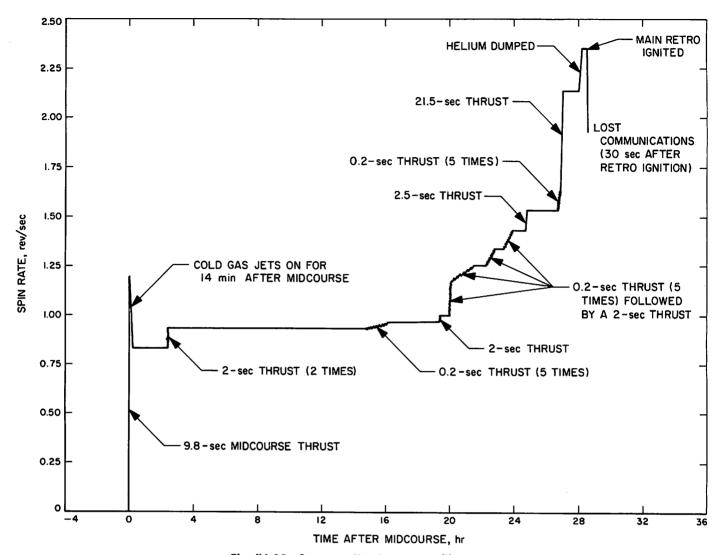
Fig. IV-11. Surveyor II spin rate profile

- (1) There is no evidence of oxidizer flow to Engine 3 during midcourse, but there is evidence of possible oxidizer flow for 2.0-sec or longer firings following midcourse—all of insufficient quantity to support combustion.
- (2) Engine 1 may have failed to ignite on any 0.2-sec commanded impulses, except for Firing 10. (Vernier engine firings are numbered consecutively beginning with the first post-midcourse firing.) This firing yielded a temperature response equivalent to that for the 2-sec or longer firings for some yet-unexplained reason. The extrapolated peak temperature for Engine 1 on Firing 26 is approximately 4 times as high as temperature responses observed

For approximately the first 16½ hr of flight, a nominal mission was achieved, including Canopus star acquisition. When the three vernier engines were commanded on for midcourse velocity correction, which lasted 9.8 sec (as preset by earth-based command), Vernier Engine 3 failed to provide thrust, causing the spacecraft to tumble at a rate of about 1.22 rev/sec.

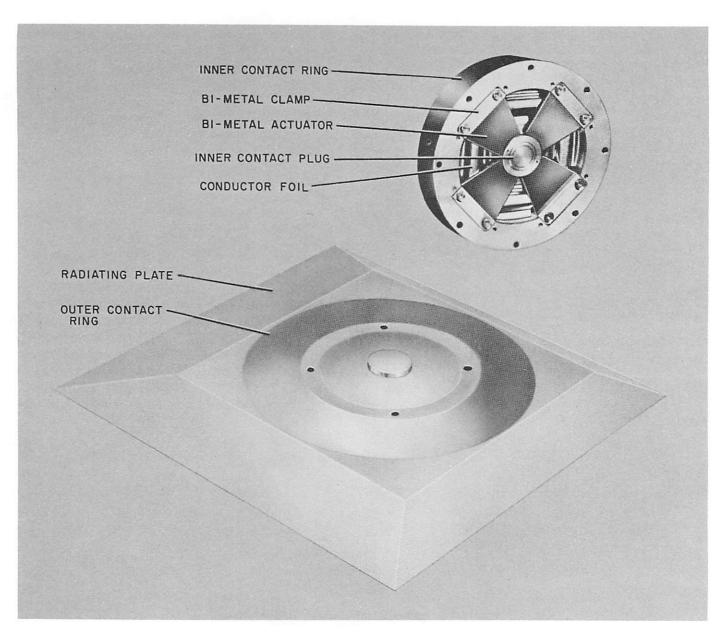
Fig. IV-14. Thermal switch

The thermal switch is a thermal-mechanical device which varies the conductive path between an external radiation surface and the top of the compartment (Fig. IV-14). The switch is made up of two contact surfaces which are ground to within one wavelength of being optically flat. One surface is then coated with a conforming substance to form an intimate contact with the mating surface. The contact actuation is accomplished by four bimetallic elements located at the base of the switch.

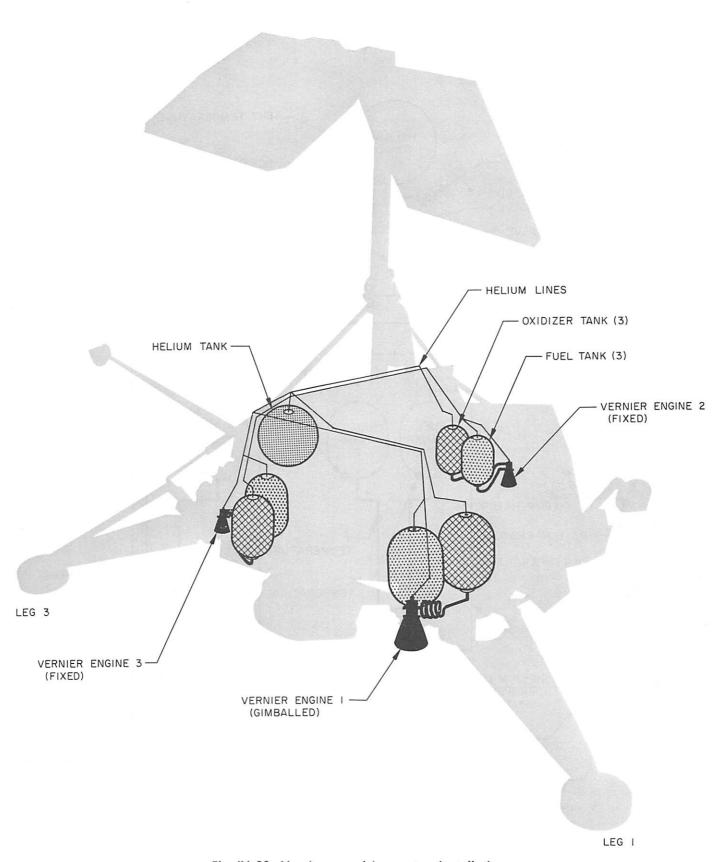
Fig. IV-30. Vernier propulsion system installation

Prior to launch the vernier propulsion system propellant tanks are loaded with a nominal 109 lb of oxidizer and 75 lb of fuel. The propellant tanks are then pressurized

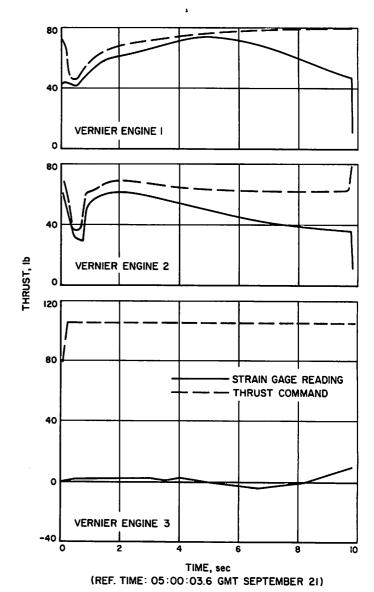
Fig. IV-33. Strain gages and thrust command signals at midcourse

During the period from launch to midcourse, all of the telemetered propulsion system data indicated normal

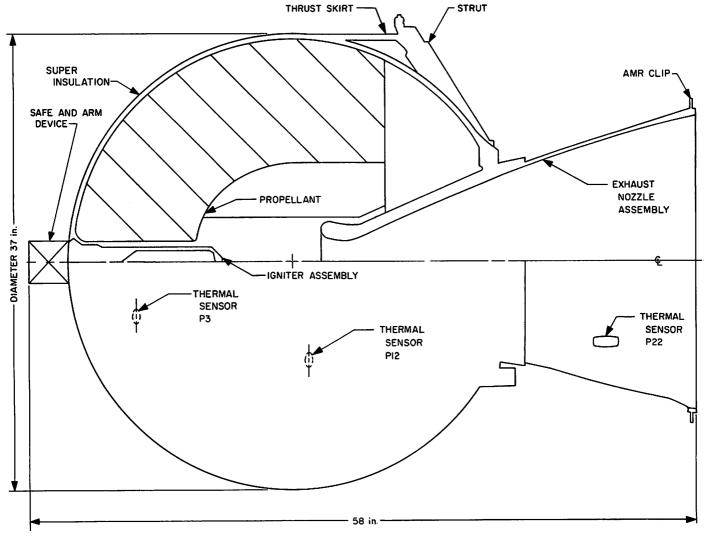
Fig. IV-34. Main retrorocket motor

Temperature histories of the propulsion subsystem components are shown in Appendix D (Figs. D-6 and D-7). Locations of temperature sensors on the vernier system are shown in Fig. IV-31, and on the main retrorocket in Fig. IV-34. During the period from launch to

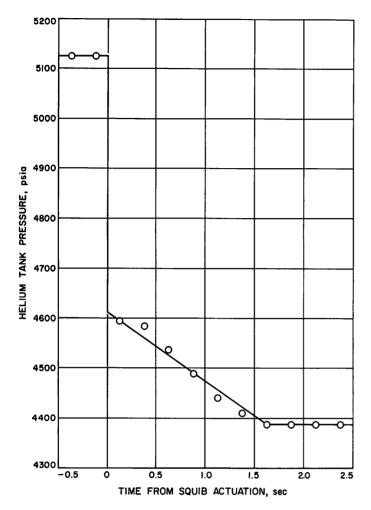
Fig. IV-36. High-resolution plot of helium supply pressure during propellant pressurization

Post-flight analysis of point-by-point telemetry data (Fig. IV-36) has revealed that the indicated helium tank

that the extreme shock load imposed by the release valve squib caused a shift of -500 to -530 psi in the null reading of the helium tank pressure transducer. Transducer null shifts associated with activation of squibactuated helium valves had been observed twice during

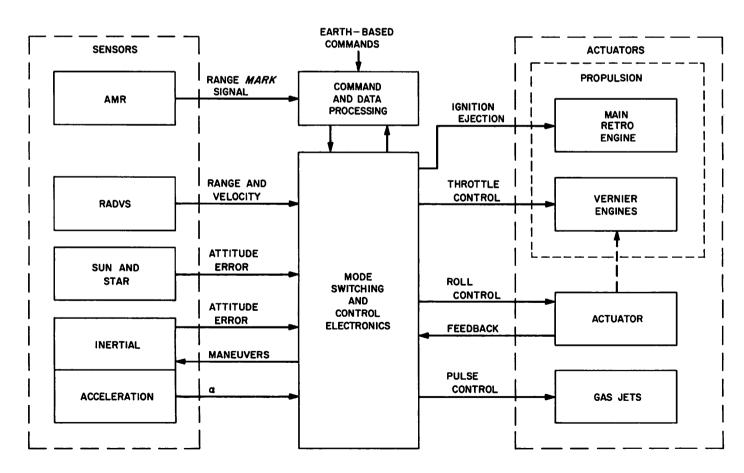
Fig. IV-37. Simplified flight control functional diagram

The control electronics process the reference sensor outputs, earth-based commands, and the flight control programmer and decoder outputs to generate the necessary control signals for use by the vehicle control elements. A simplified flight control functional diagram appears in Fig. IV-37. The vehicle control elements consist of the attitude-control gas-jet activation valves, the vernier engine thrust level control valves and gimbal

actuator, and the main retro motor ignitor and separation pyrotechnics.

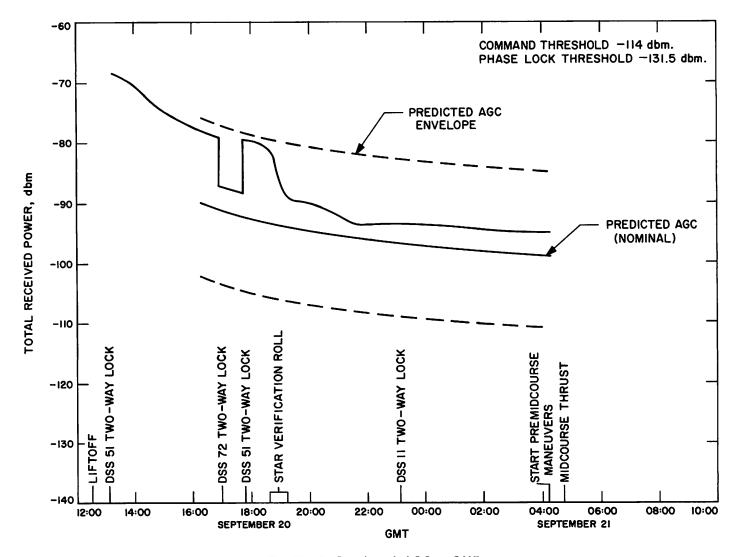
Fig. IV-47. Receiver A AGC vs GMT

Three hours prior to launch, the receiver AGC problem was first questioned but not identified. Spacecraft telemetry indicated that Receiver A was receiving 25-db more signal than Receiver B. Previous data recorded 9 hr prior to launch indicated only a 9-db difference. The fact that

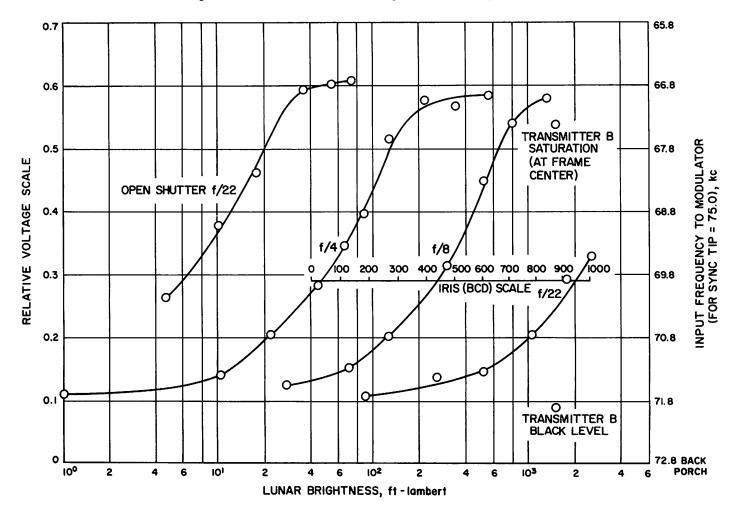
Fig. IV-64. Camera 200-line light transfer characteristic as a function of lunar brightness

The calibration results, at the point of initial FM recording (i.e., not including the GSE), are shown in Figs. IV-63 through IV-68. Figure IV-63 represents a

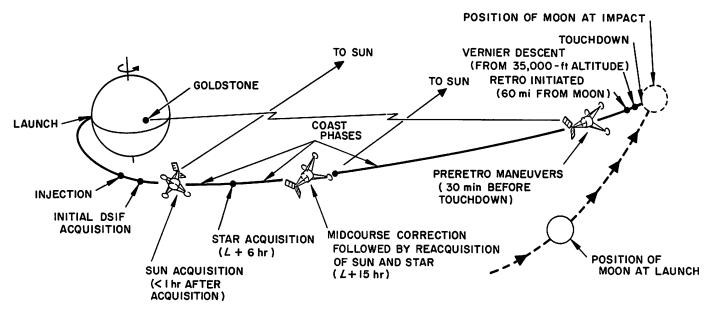
Fig. VII-1. Earth-moon trajectory and nominal events

The nominal earth-moon transfer trajectory and events are shown in Fig. VII-1. A plot of the actual Surveyor II trajectory projected on the earth's equatorial plane is provided in Fig. VII-2. The earth track traced by Surveyor II appears in Fig. VII-3. Specific events such as sun and Canopus acquisition and rise and set times for the DSIF stations are also noted.

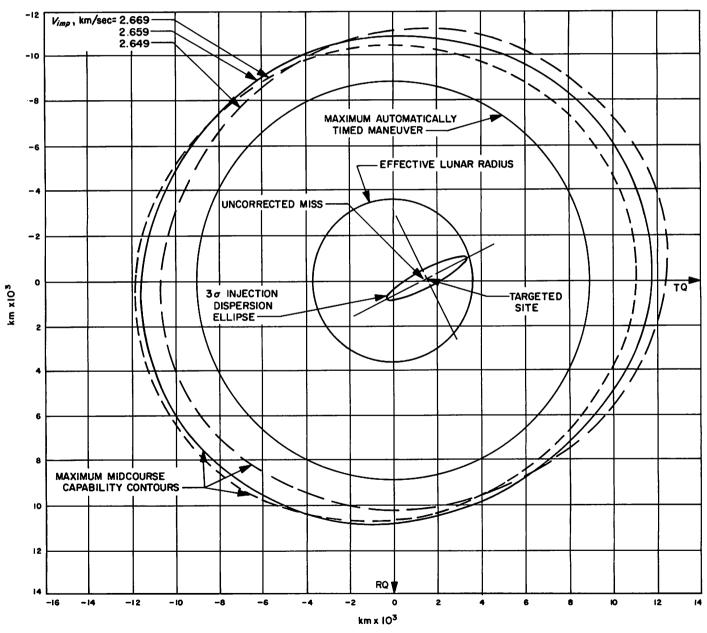
Fig. VII-6. Midcourse capability contours for September 20 launch

A midcourse correction of 9.587 m/sec was selected for execution by the spacecraft. The velocity component in the critical plane, to correct "miss only," was 1.185 m/sec. This component is referred to as the critical component. The velocity component normal to the critical component is referred to as the noncritical component since it does not affect the miss to first order. Figure VII-7 presents the variations in flight time, main retro burnout velocity, and vernier propellant margin with the noncritical velocity component  $\dot{U}_3$ . The propellant margin and flight time were acceptable within the limits shown. However, it was desirable to (1) provide backup midcourse correction
